# **PREVENTIVE MAINTENANCE OF SUSPENDER ROPES ON THE HONSHU-SHIKOKU SUSPENSION BRIDGES**

*Honshu-Shikoku Bridge Expressway Co.Ltd*

This paper presents a maintenance policy of suspender ropes of the Honshu-Shikoku Bridges especially repair methods.

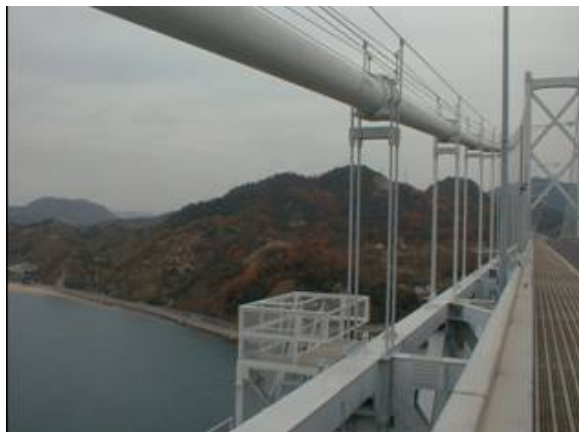
Photo 1. The CFRC type suspender ropes at the Innoshima Bridge

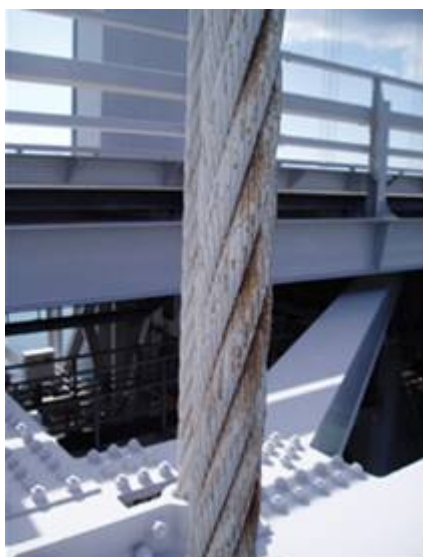
(1) Corrosion among the majority of suspender ropes: In case of the Innoshima Bridge, damage and rust of all rope surfaces were found. However internal corrosion was not detected by external appearance.

Photo 2. Surface condition of a suspender rope (Innoshima Bridge) (Left)

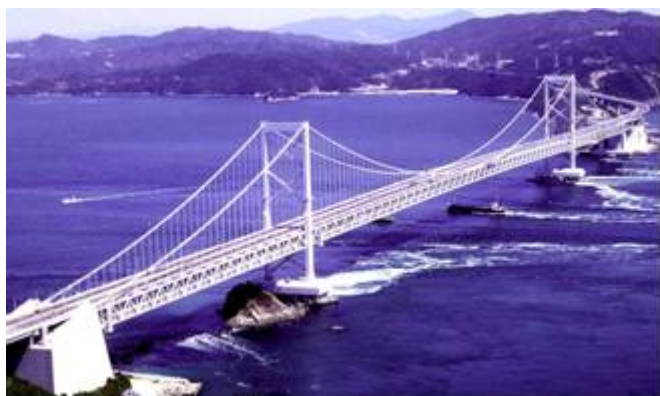
Photo 4. The whole view of the Ohnaruto Bridge (Left)

(2) Corrosion of the anchorage-parts of suspender ropes: Severe corrosion of the anchorage-parts of ropes was found at the Ohnaruto Bridge. The location of the bridge is a channel where the Seto- Inland Sea meets the Pacific Ocean and the place is often attacked by typhoons and strong seasonal winds in winter. The basic design speed is 50 m/sec. (at 10m high, 10 minute average) and this is the highest speed among the Honshu-Shikoku Bridges. A chemical analysis of attached rust and dust showed the cause of corrosion were salt and exhaust gas.

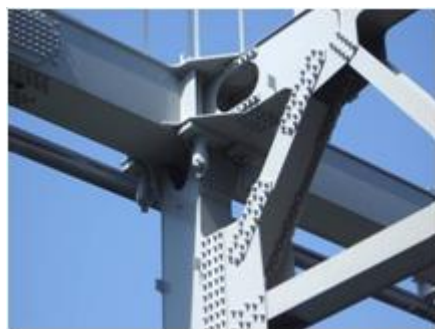
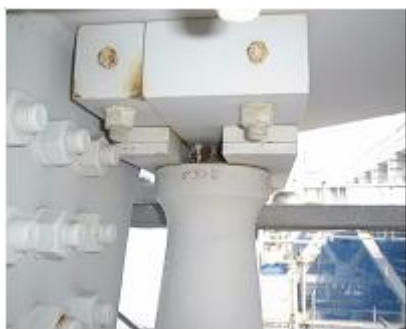
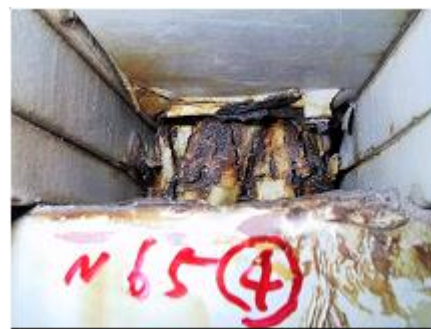
Photo 5. Anchorage of ropes (Left), Corrosion in a socket (Center), Close up view of a corroded rope(Right)

To confirm the condition of the Ohnaruto Bridge, four suspender ropes were removed and were investigated using Main Flux Method, tensile tests and disassembly tests at a laboratory. The test results were, 1) Decrease of the cross-sectional area of the great majority of suspender ropes was 0.5 – 0.8 %, it means the major parts were in sound condition. 2) However decrease of the area of the anchorage-parts was maximum 10.5 %. 3) Decrease of the tensile strength of ropes was maximum 29% for a loss of 10.5 % sectional area. 4) Breaking points of the corroded ropes at the anchorages were the mouth of sockets. According to the above mentioned results, we did a site investigation of ropes using non-destructive inspection technique, i.e. Main Flux Method. Then more severe corrosion at anchorage- part was found. The maximum decrease of the cross-sectional area was 15 %.

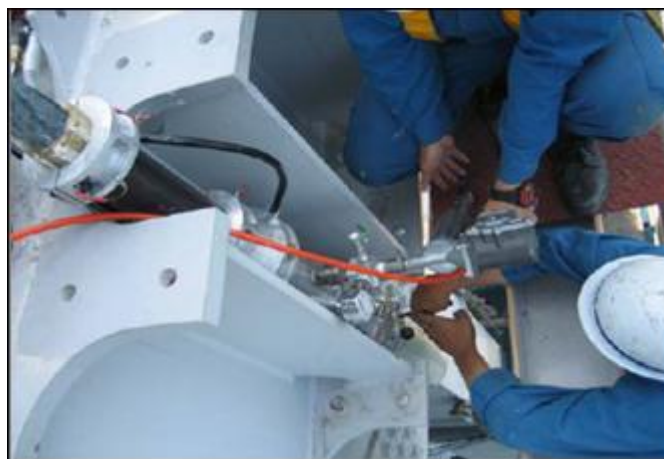
When corrosion is observed as an early stage and is found in progress at anchorage-parts of suspender ropes, we are planning to adopt the Filling Up Method (FUM) for a countermeasure of the prolonging lifetime. An outline of the method and the procedure are shown in followings:-

Figure 6. The Filling Up Method (FUM)

When the method is adopted appropriate viscosity and pressure of filling-materials, leakages of material are found in about 10 minutes at the top outlet and about 1 minute at the bottom outlet if a strand is not choked by rusts.

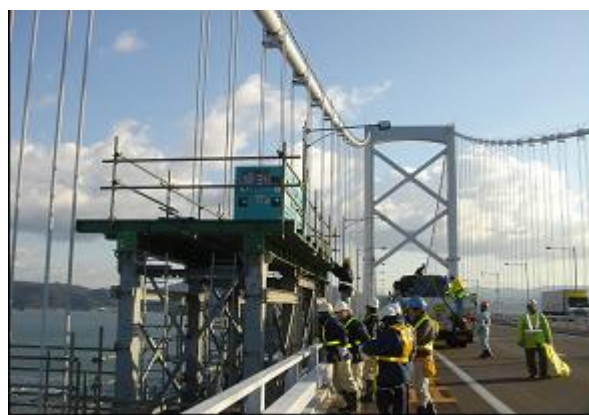
Photo 8. Assembling of a platform

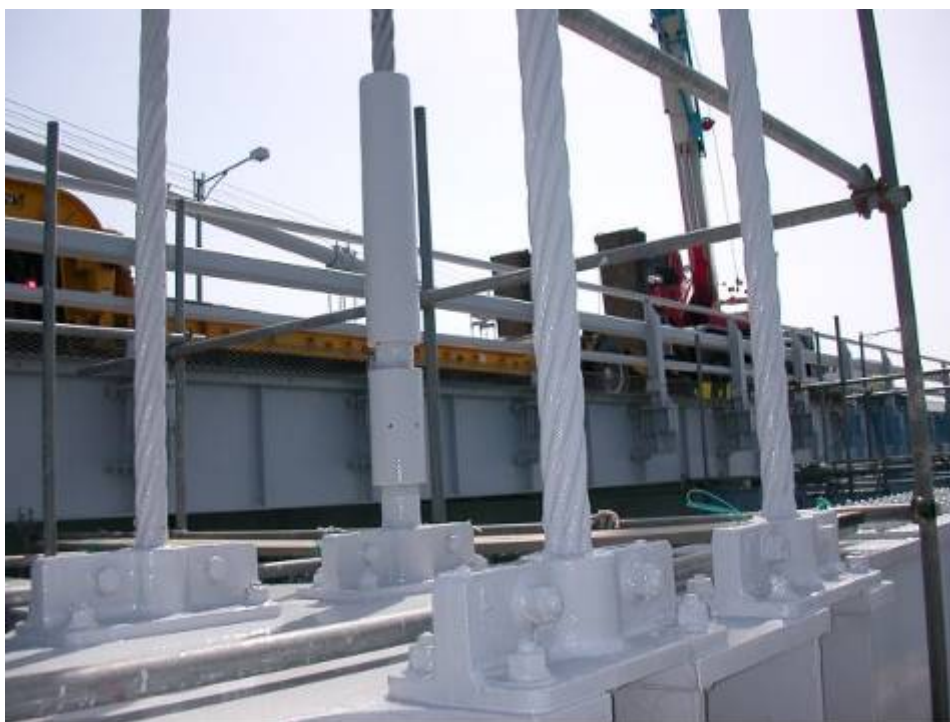
Completion of the PRM is shown in Photo 9.

Photo 9. Partial replacement of a suspender rope (the Ohnaruto Bridge)

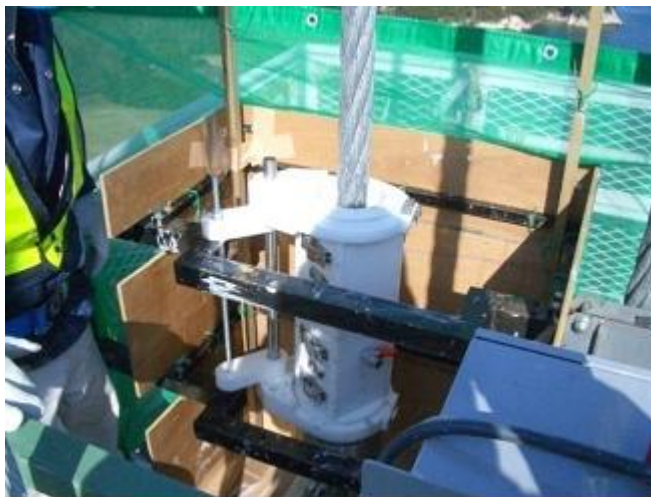
other is the dipping painting. The blush painting is a traditional method done by painters while the dipping painting is using a dipping machine which is like a container of paint and is moved along ropes by a winch. Finally the dipping painting was selected as a basic method. The reasons are, 1) Suspender ropes of the Innoshima Bridge were painted by the dipping painting and the brush painting. The dipping method was used for the center span and one outer span while the brush method was used for one outer span. To check the internal corrosion, the non-destructive inspection using the Main Flux Method was done for both painted ropes. Results showed the dipping painting was more sound condition than the blush painting [1]. In case of the Ohnaruto Bridge, the dipping painting has adopted for all suspender ropes, its condition was more sound than the blush- painted ropes of the Innoshima Bridge. 2) According to a surface observation, the coating film of the dipping painting has attached well on grooves of the external strands than the film of the blush painting. That means, the dipping paint has higher waterproof performance than the blush painting. At present, the dipping paint is two coats system.

Photo 10. Dipping painting and the dipping machine (Left)
